Transvenous extraction of an implantable cardioverter-defibrillator lead looped and damaged in subclavian vein

Andrzej Ząbek¹, Barbara Małecka¹, Jacek Lelakowski¹, Małgorzata Hardzina¹, Roman Pfitzner²

¹Department of Electrophysiology, John Paul II Hospital in Krakow, Krakow, Poland

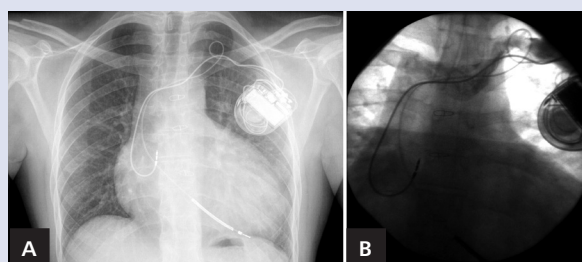
Figure 1. A. X-ray PA projection; B. Left subclavian venography

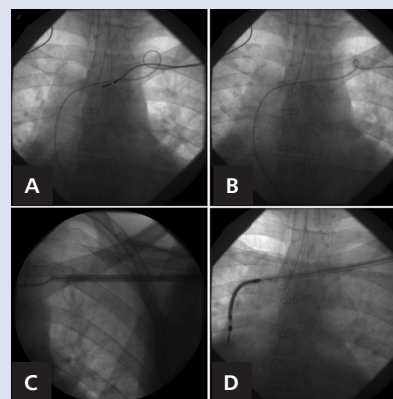
Figure 2. A–D. X-ray during lead extraction

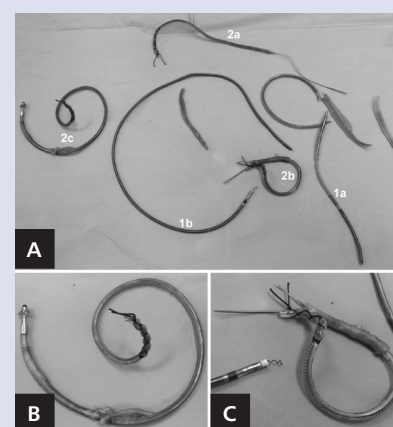
Figure 3. A. All removed fragments of atrial and ventricular leads (1a and 1b — atrial proximal and distal; 2a, 2b, 2c — ventricular proximal, looped and distal with coil); B. Distal ventricular with connective tissue; C. Ventricular loop with tissue adherence to subclavian vein
